NRC INSPECTION CONDUCTED ON FEBRUARY 13, 1996 AT MALLINCKRODT

CHEMICAL, INC. (INSPECTION NO. 040-06563/96001 (DNMS))

Report No. 040-06563/96001(DNMS)

Licensee: Mallinckrodt, Inc.

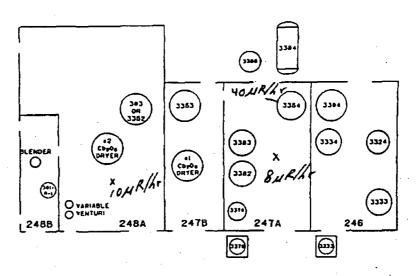
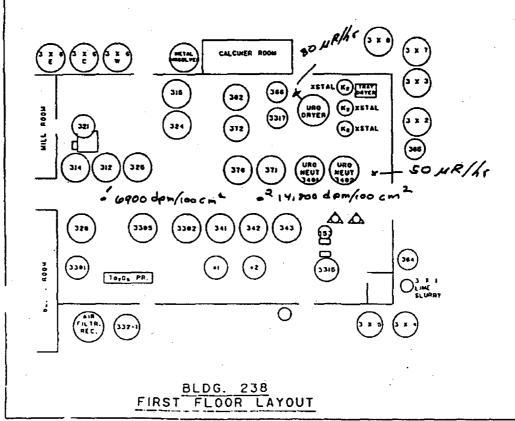
Figure A: Buildings Diagram

Direct measurements were performed at two locations on the floor of Building 238 and were 14,800 and 6900 disintegrations per minute per 100 square centimeters (dpm/100 cm 2) (247 and 115 becquerels per 100 square centimeters (Bq/100 cm 2)) beta/gamma activity. Wipes were collected at each direct measurement location and analyzed for gross alpha and beta activity. The two wipe results analyzed indicated less than (<) 5 dpm (<0.1 Bq)/100 cm 2 each for gross alpha and gross beta activity.

Exposure rate measurements were performed at several locations in buildings 238, 247, and 248. The exposure rates ranged from 8 to 80 μ R/hr (0.08 to 0.8 μ Sv/hr). See attached figure for location of direct measurements and exposure rate measurements.
